HOME INSPECTION

07/19/17

11801 Oak Point Ct
Henrico, VA 23233

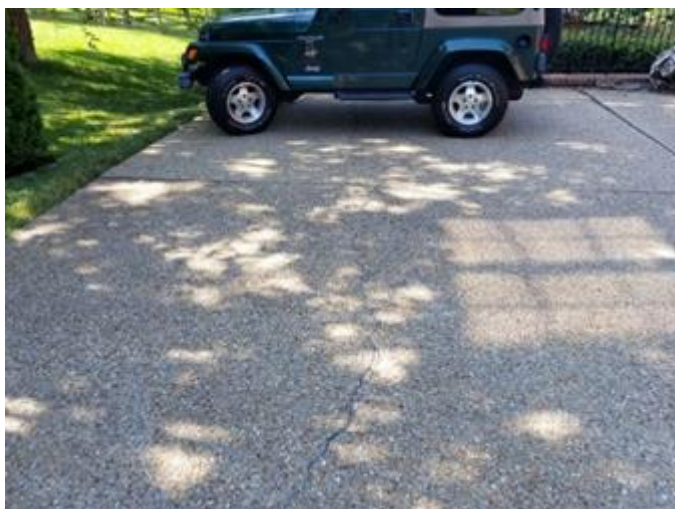
Issue	The driveway has cracked and settled/heaved. Cracks permit moisture to enter, which can cause further damage. Uneven walking surfaces are trip hazards.
Location	Rear left section of the driveway
Action	<i>Hire a contractor to make required repairs.</i>
Cost	\$360 - \$540

- 01 The driveway has cracked and settled/heaved. Cracks permit moisture to enter, which can cause further damage. Uneven walking surfaces are trip hazards. Location: Rear left section of the driveway. *Hire a contractor to make required repairs.* Estimated cost: \$360 - \$540

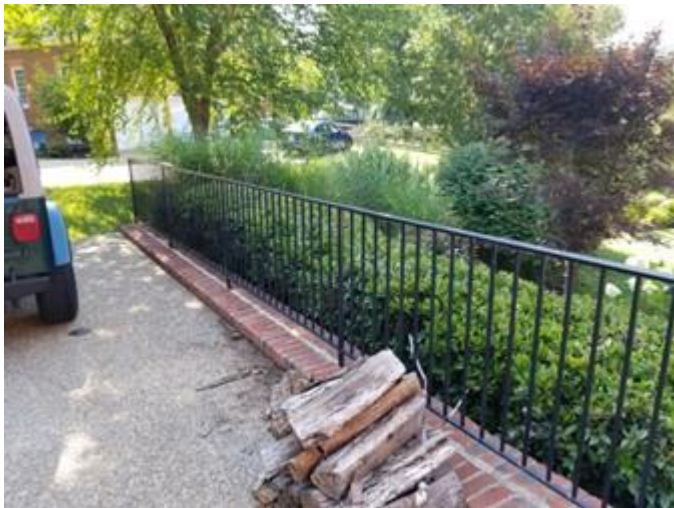
Exterior - Retaining Wall

✕ Issue The guardrail at the retaining wall is loose.
Location Rear left side
Action *Hire a contractor to make required repairs.*
Cost \$220 - \$330

- 02 The guardrail at the retaining wall is loose. Location: Rear left side. *Hire a contractor to make required repairs.* Estimated cost: \$220 - \$330

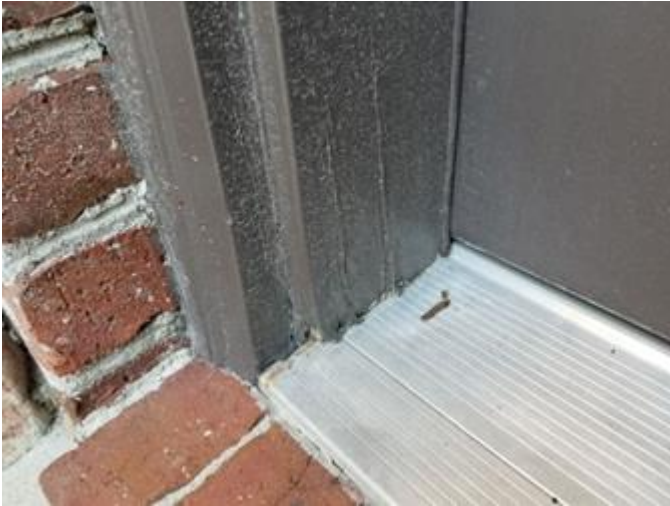
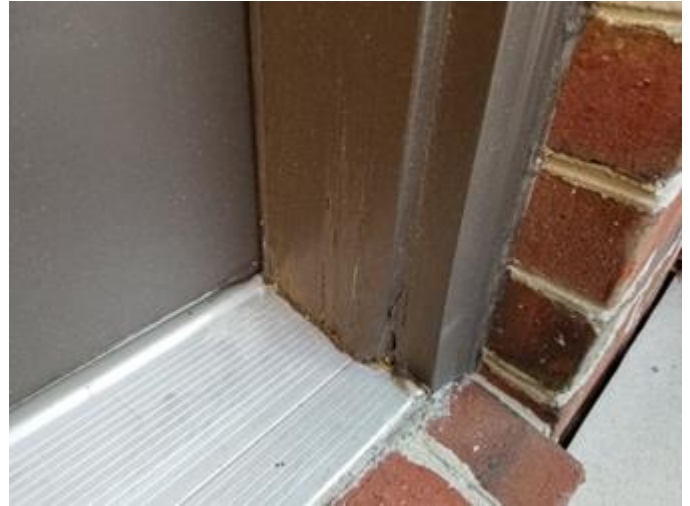
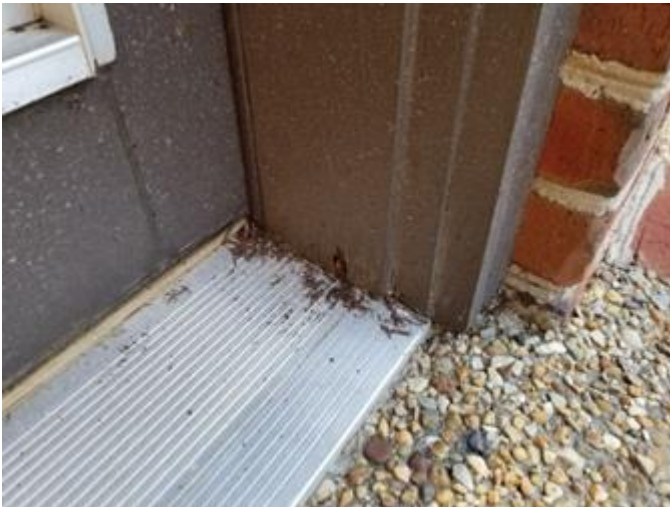
Issue	The trim is damaged or deteriorated. This permits moisture to enter and will cause further deterioration. There may be hidden damage behind the trim.
	Location	Bottom sections at the rear middle deck door and both garage pedestrian doors
	Action	<i>Replace the trim and repair damage which may be revealed.</i>
	Cost	\$260 - \$390

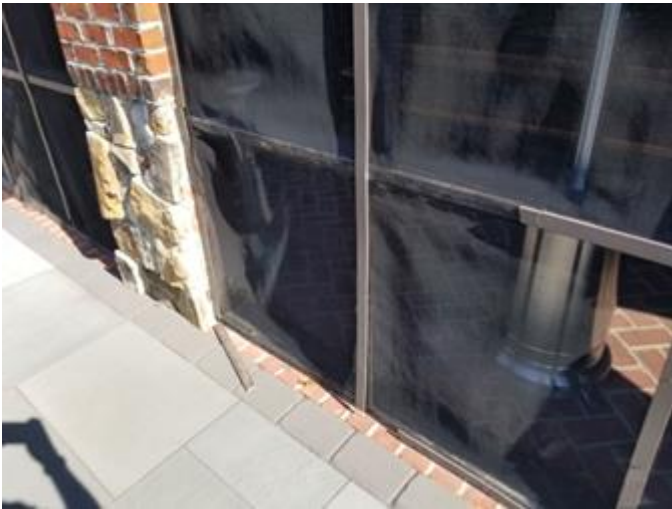
- ✕ **Issue** The trim is loose or missing. This permits moisture to enter.
- Location** Rear porch
- Action** *Repair or replace the trim.*
- Cost** \$100 - \$150

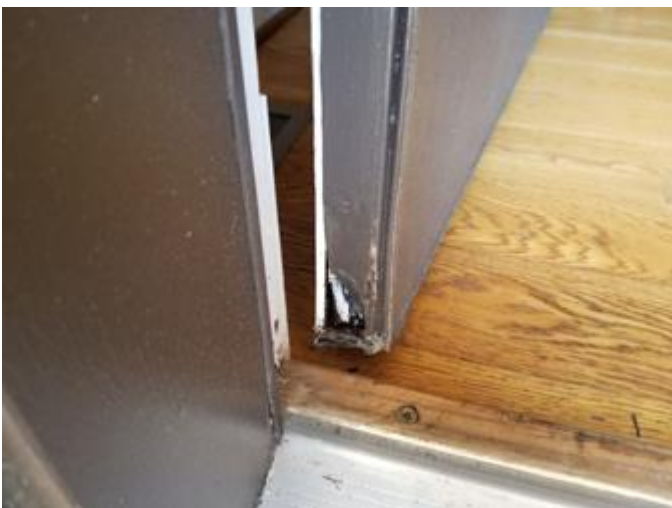
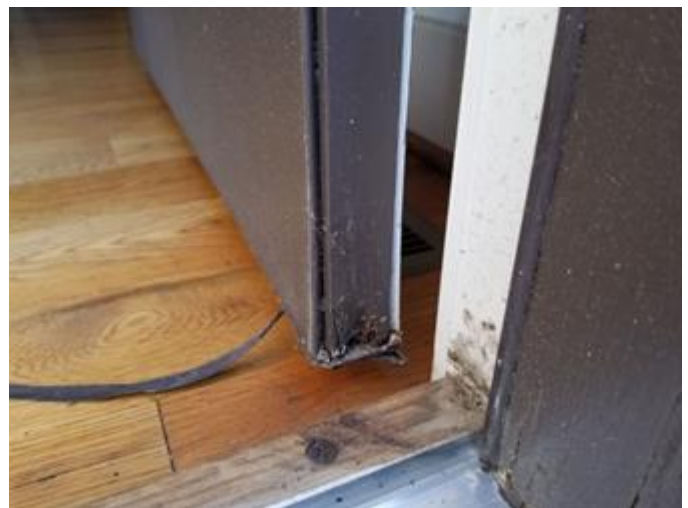
Exterior - Doors

- ✕ **Issue** The door is deteriorated.
- Location** Bottom corners at all 3 rear deck doors
- Action** *Replace the deteriorated doors.*
- Cost** \$960 - \$1440

- 05 The door is deteriorated. Location: Bottom corners at all 3 rear deck doors. *Replace the deteriorated doors.* Estimated cost: \$960 - \$1440

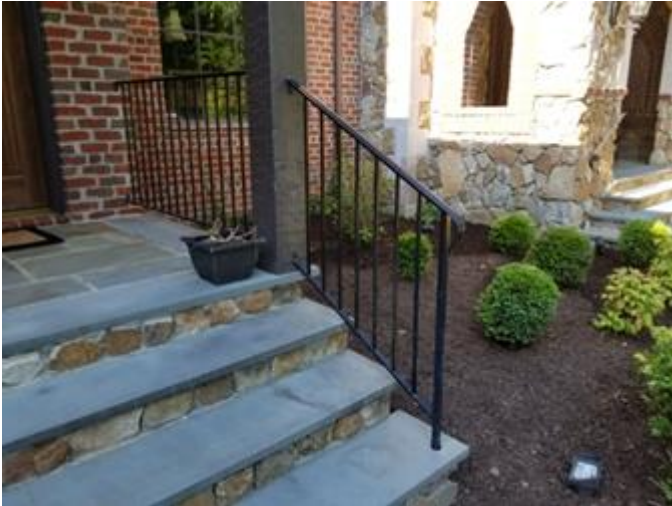
- X **Issue** The handrail is loose. This is a safety hazard.
- Location** Front left entrance steps, right side handrail and the rear left steps
- Action** *Repair or replace the handrail.*
- Cost** \$240 - \$360

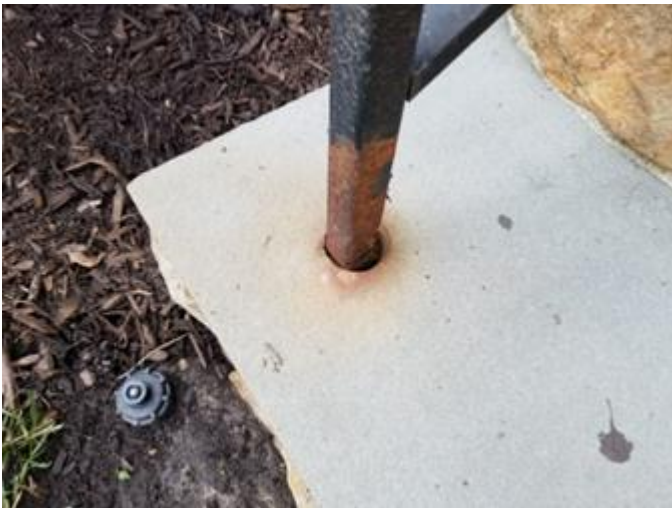
- X **Issue** There are open post holes at the handrails.
- Location** Front and rear
- Action** *Hire a contractor to make required repairs.*
- Cost** \$80 - \$120

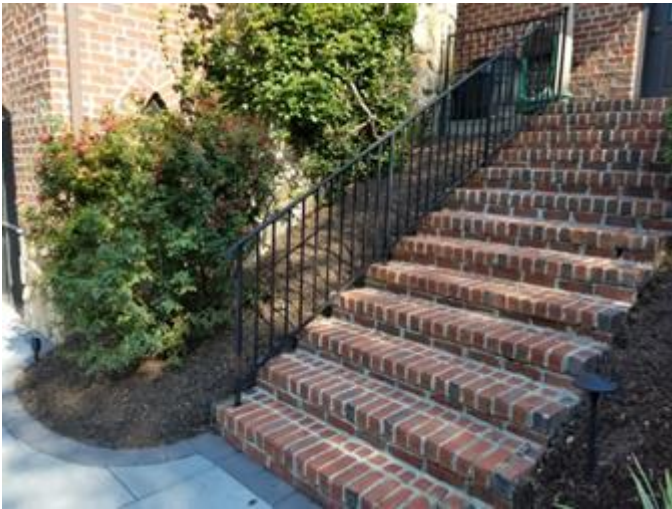
- ✕ Issue The handrail is damaged and corroded.
- Location Rear left steps
- Action *Replace the handrail.*
- Cost \$240 - \$360

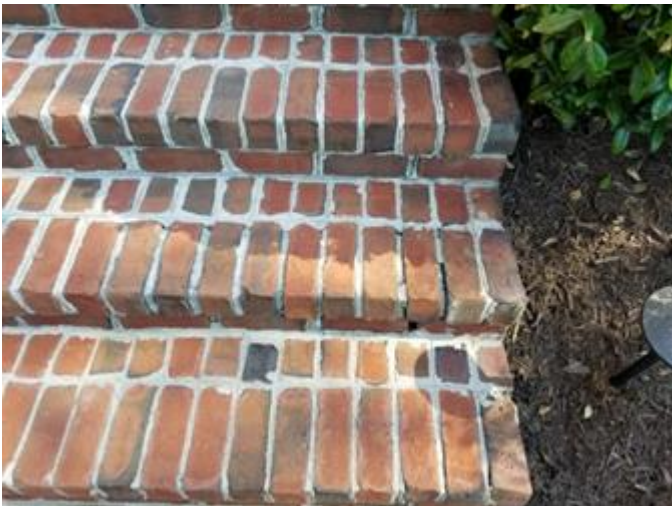
- ✕ Issue The mortar joints at the steps are deteriorated.
- Location Rear left steps
- Action *Hire a contractor to make required repairs.*
- Cost \$120 - \$180

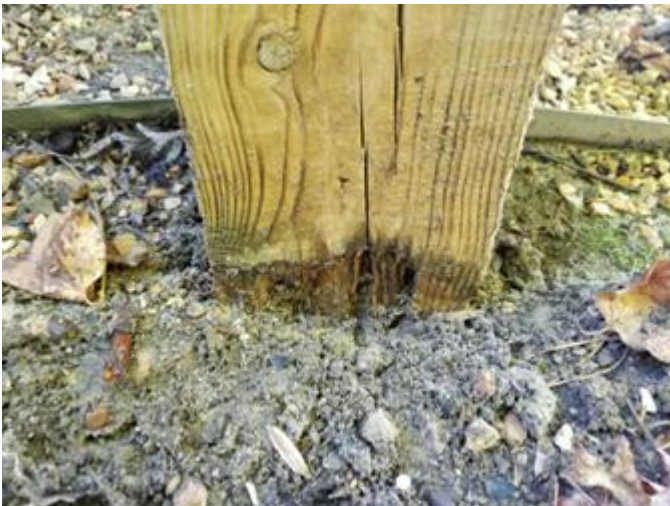
- X Issue The deck support post exhibits minor deterioration.
- Location Rear deck, right side post
- Action *Hire a contractor to make required repairs.*
- Cost \$200 - \$300

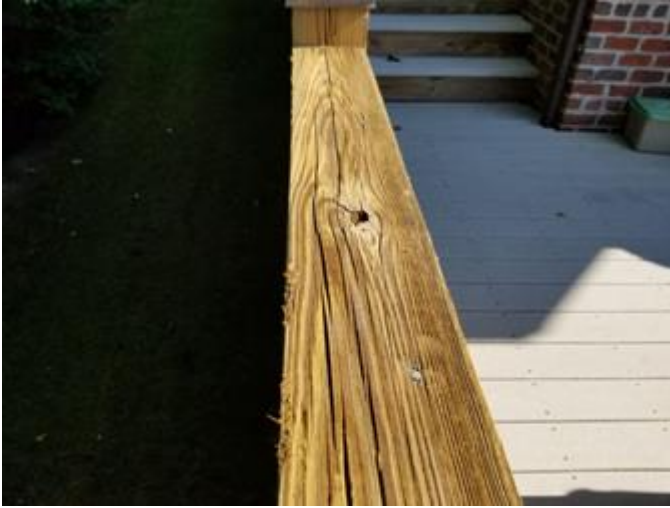
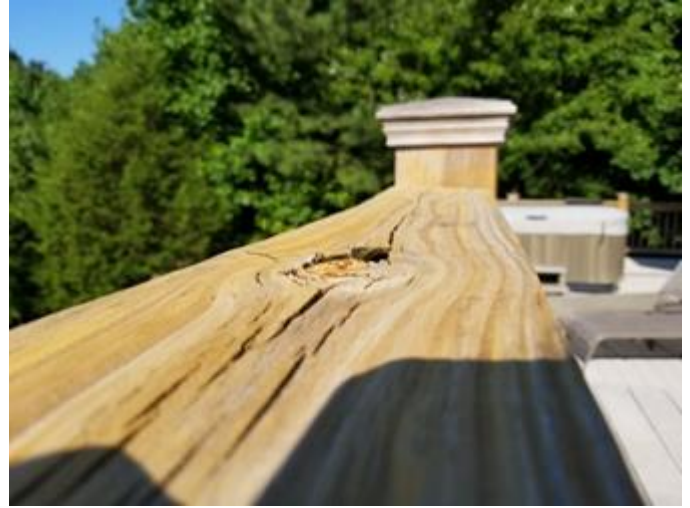
- X** Issue The guardrails have splinters. This is a personal injury hazard.
Location Throughout the rear deck
Action *Repair or replace the guardrail.*
Cost \$220 - \$330

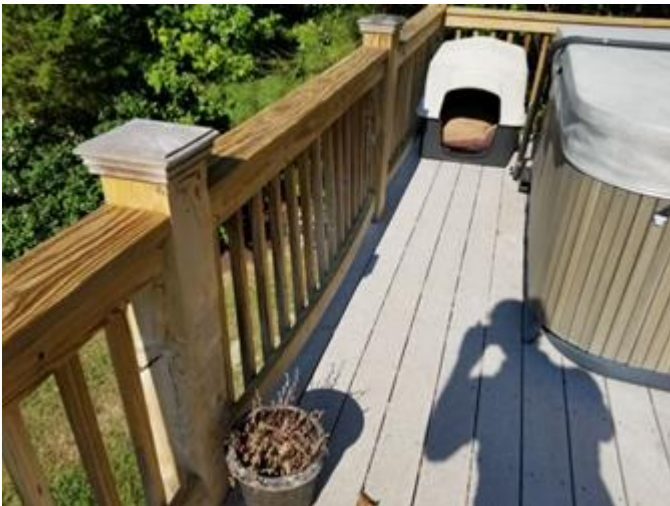
- X** Issue A section of the guardrail is warped.
Location Rear right section of the deck
Action *Repair or replace the guardrail.*
Cost \$160 - \$240

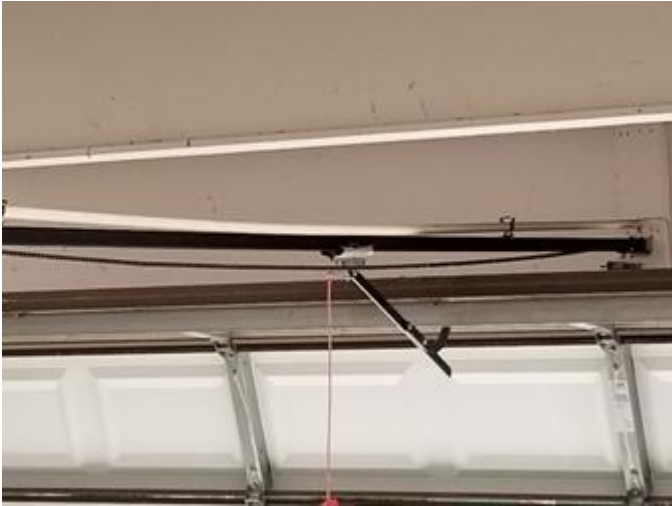
Exterior - Garage Vehicle Door Opener

- X** Issue The chain on the automatic garage door opener has too much slack. This allows shocks to the mechanism during operation and can cause the chain to break or come off.
- Location Right side garage door
- Action *Hire a contractor to make required repairs.*
- Cost \$120 - \$180

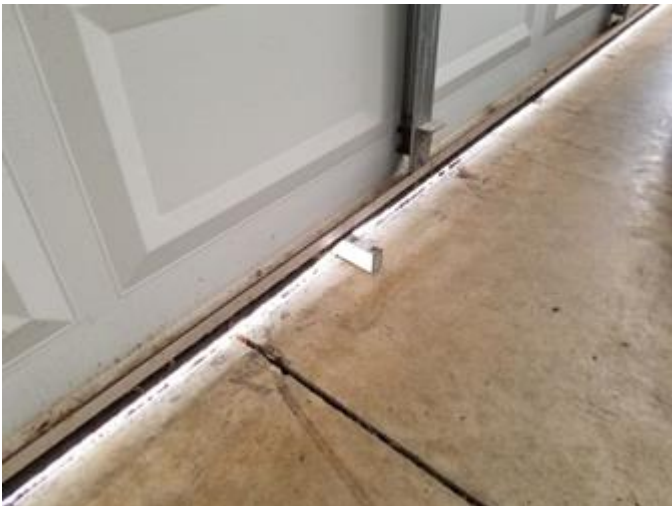
- X** Issue The automatic opener does not reverse properly at the garage vehicle door. It should reverse within 2 seconds of closing on a 1 - 1.5" object placed on the floor. This is a safety hazard.
- Location Right side garage door
- Action *Hire a contractor to make required repairs.*
- Cost \$100 - \$150

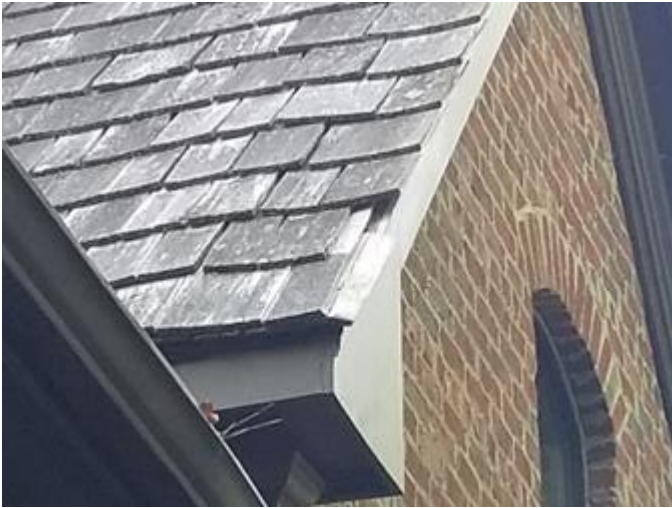
Roof - Covering

- ✕ Issue The roofing is damaged. This permits water penetration.
- Location Right side
- Action *Repair or replace the roofing.*
- Cost \$200 - \$300

- 16 The roofing is damaged. This permits water penetration. Location: Right side. *Repair or replace the roofing.* Estimated cost: \$200 - \$300

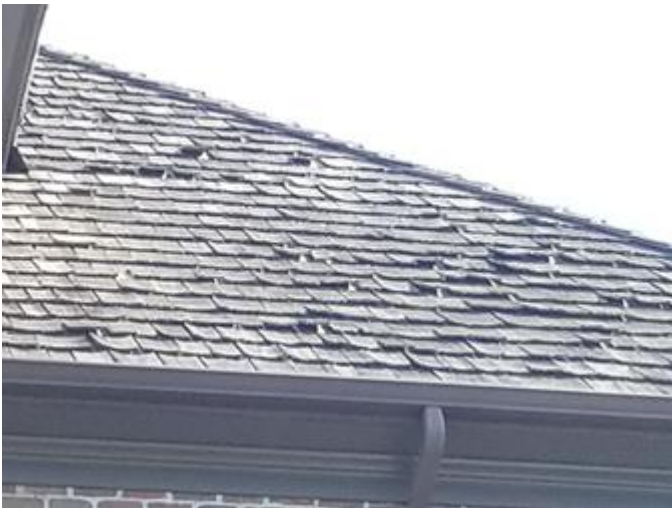
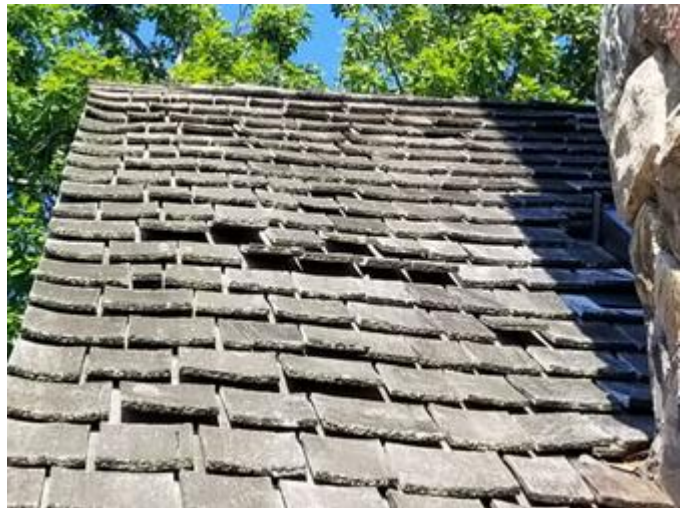
- ✕ Issue The roofing is lifted. This permits water penetration.
- Location Throughout the front and rear
- Action *Hire a contractor to make required repairs.*
- Cost \$480 - \$720

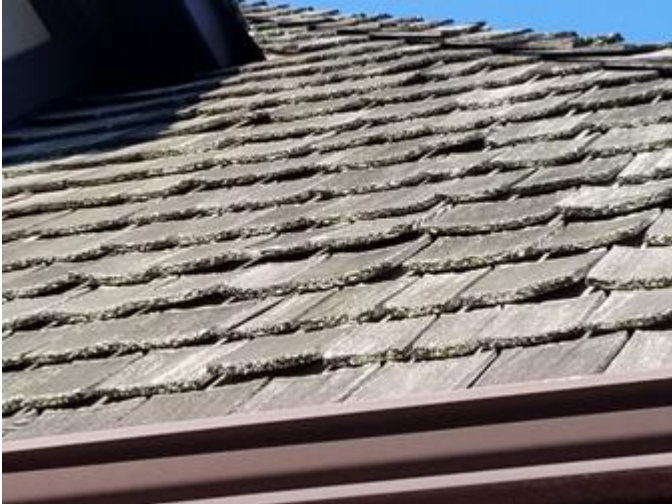
- X** Issue There is moss, mold, or other biological build-up on the roof covering. The growth may damage the roof covering and cause premature deterioration or failure.
- Location Throughout the roof
- Action *Clean the roofing.*
- Cost \$240 - \$360

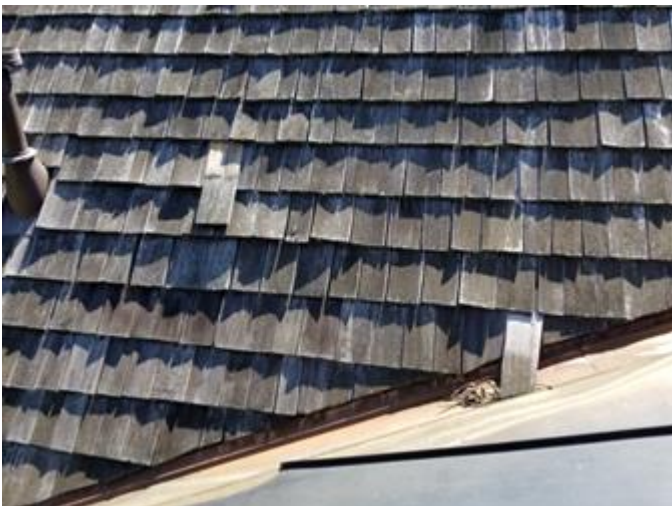
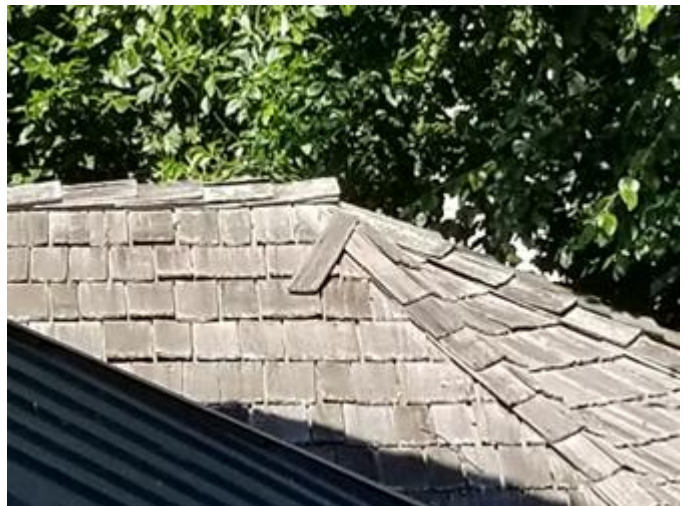
- X** Issue The roofing is loose. This permits water penetration.
- Location Front left and right sections
- Action *Hire a contractor to make required repairs.*
- Cost \$200 - \$300

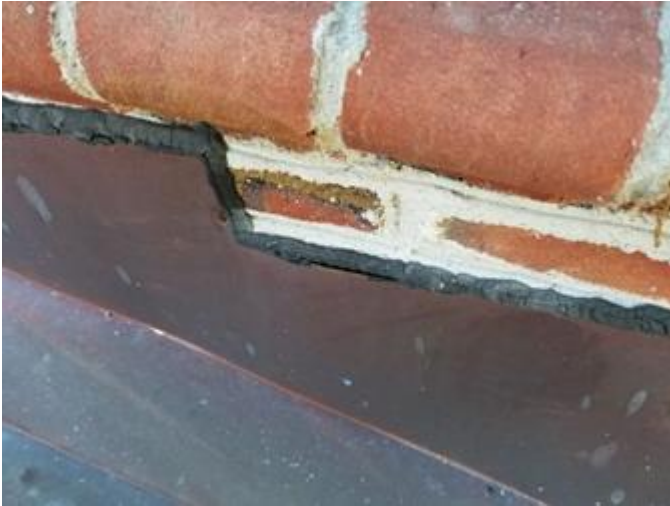
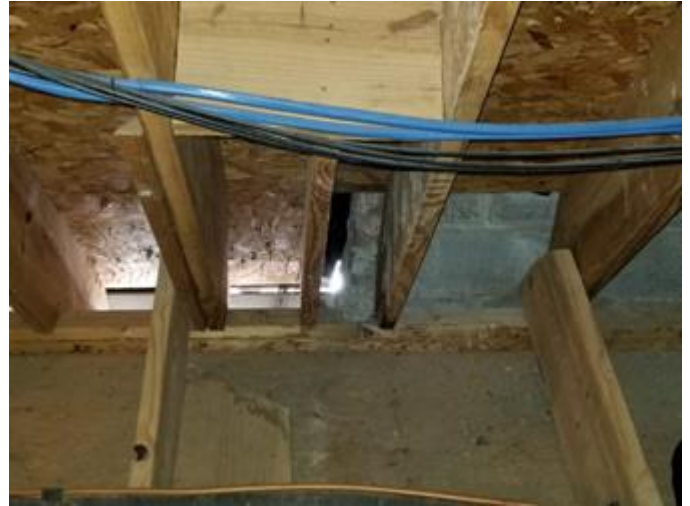
Roof - Flashing

- X** Issue There is a gap in the flashing. This can allow water to enter, causing deterioration of the materials behind and under the flashing. The condition of the materials behind and under the flashing could not be determined and hidden damage may exist.
- Location Above the front metal roofs and the rear right corner of the attic
- Action *Hire a contractor to make required repairs.*
- Cost \$180 - \$270

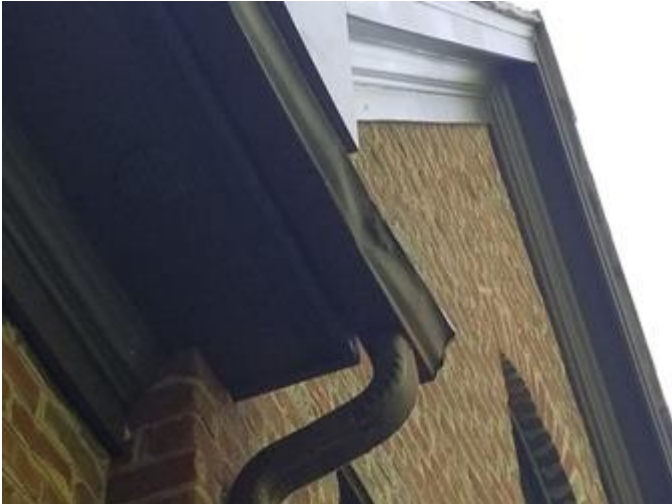
- ✕ Issue The gutters are damaged. This affects proper water control and permits water intrusion and deterioration.
- Location Attached garage
- Action *Repair or replace the gutters.*
- Cost \$240 - \$360

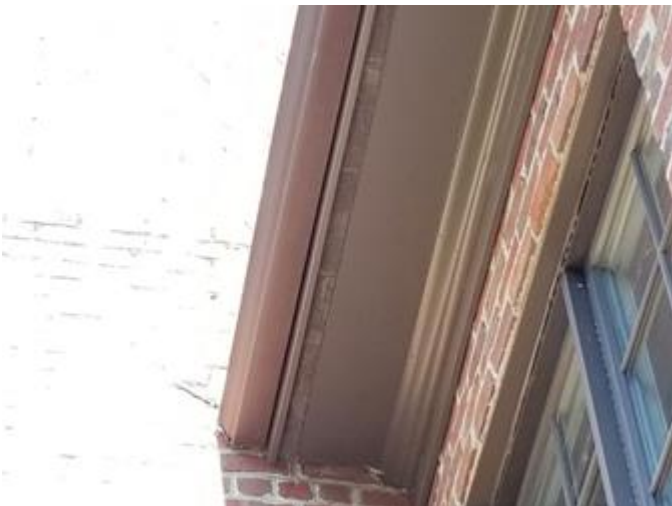
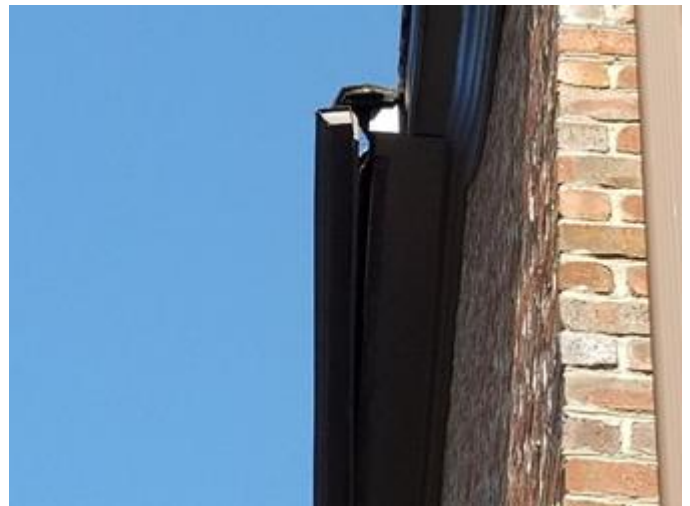
- ✕ Issue The gutters are loose. This affect proper water control and permits water intrusion and deterioration.
- Location Upper rear middle and rear left sections
- Action *Secure the loose gutters.*
- Cost \$140 - \$210

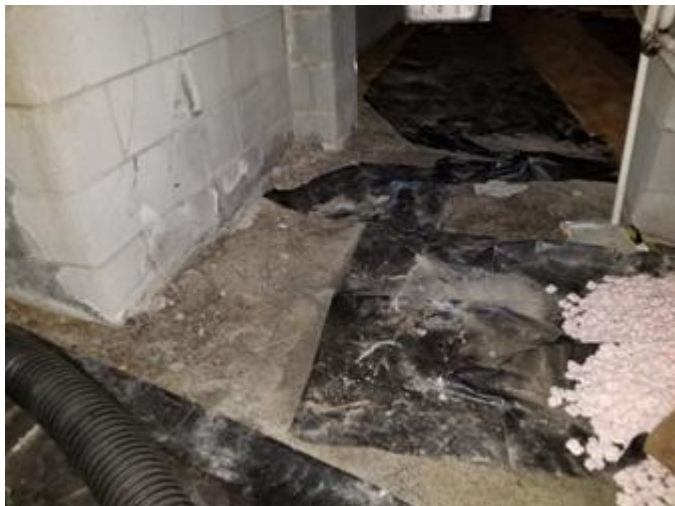
Insulation and Ventilation - Humidity Control

- X **Issue** The crawl space vapor retarder does not cover all areas. This will raise the humidity and is conducive to moisture related problems.
- Location** Throughout the crawlspace
- Action** *Repair or replace the vapor retarder.*
- Cost** \$200 - \$300

- 23 The crawl space vapor retarder does not cover all areas. This will raise the humidity and is conducive to moisture related problems. Location: Throughout the crawlspace. *Repair or replace the vapor retarder.* Estimated cost: \$200 - \$300

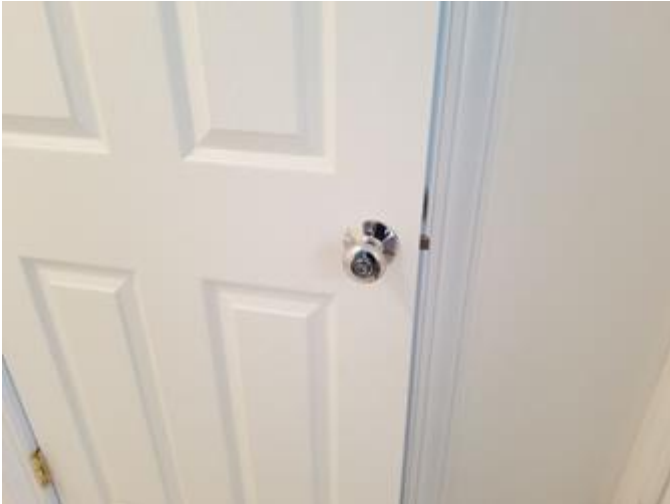
- X Issue The door will not latch shut.
- Location Throughout the house
- Action *Repair or replace the hardware.*
- Cost \$100 - \$150

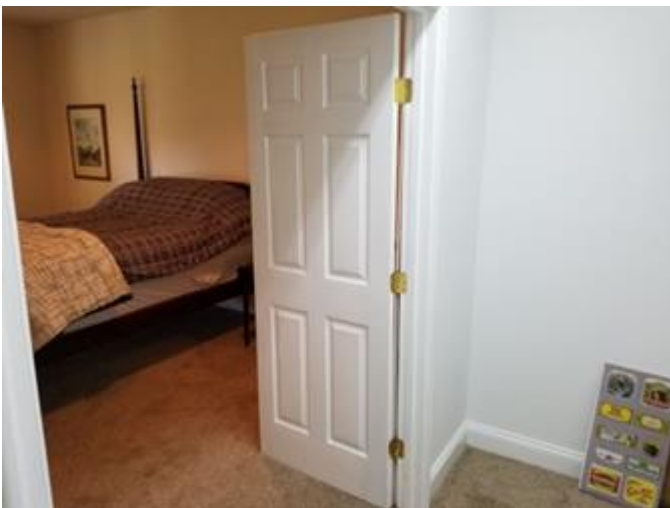
- X Issue The door frame is loose.
- Location Basement bedroom closet doors
- Action *Hire a contractor to make required repairs.*
- Cost \$80 - \$120

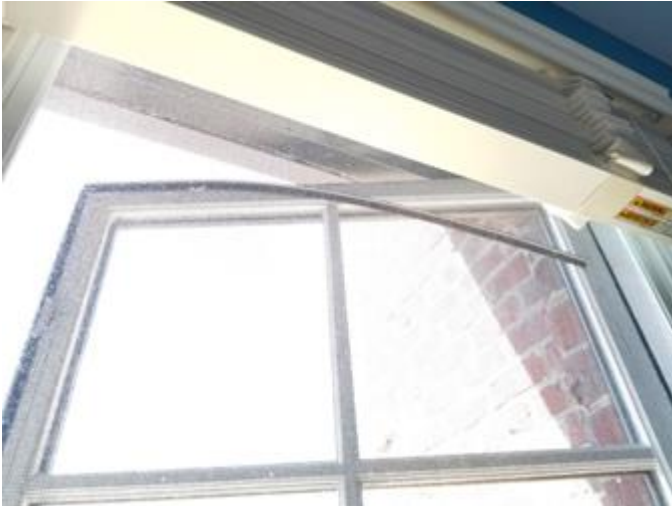
Interior - Windows

- ✕ Issue The weather stripping at the window is damaged.
Location 2nd floor, Rear right bedroom
Action *Repair or replace the weather stripping.*
Cost \$60 - \$90

- 26 The weather stripping at the window is damaged. Location: 2nd floor, Rear right bedroom. *Repair or replace the weather stripping.* Estimated cost: \$60 - \$90

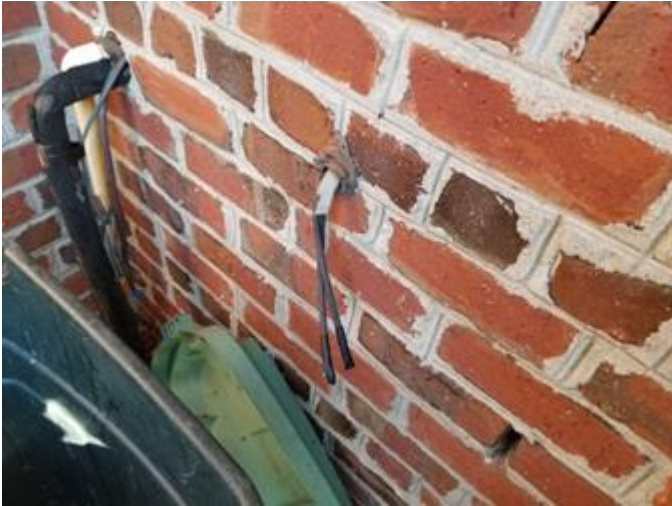
Electrical - Branch Circuits

- ❌ **Issue** There are exposed branch circuit ends. All wire terminations must be in a permanently-accessible approved junction box, with a cover, for safety. This is a safety hazard.
- Location** Rear left section behind the garage
- Action** Hire an electrician to make required repairs.
- Cost** \$120 - \$180

- 27 There are exposed branch circuit ends. All wire terminations must be in a permanently-accessible approved junction box, with a cover, for safety. This is a safety hazard. Location: Rear left section behind the garage. *Hire an electrician to make required repairs.* Estimated cost: \$120 - \$180

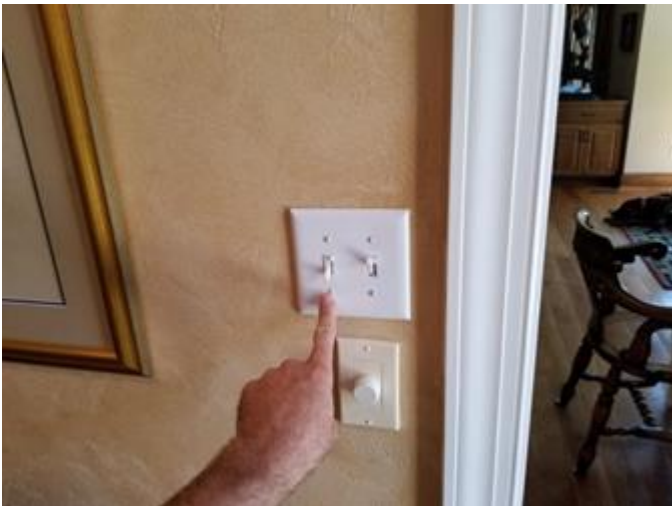
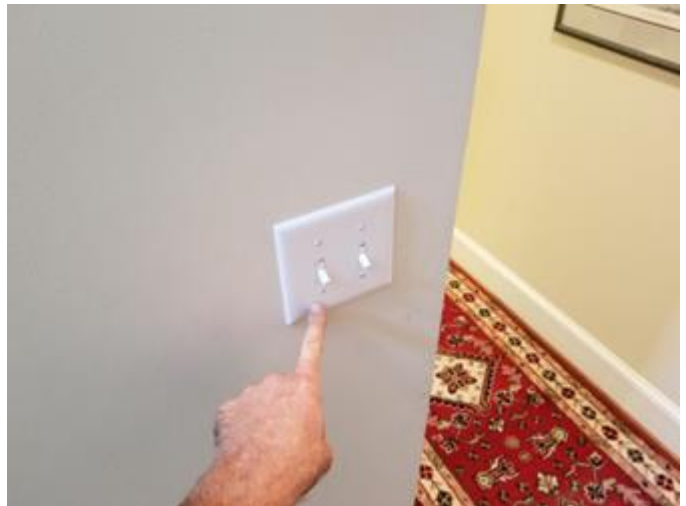
Electrical - Switches

- ❌ **Issue** The switch is an improperly-wired three way switch. This affects proper function, and can be a shock hazard and safety concern.
- Location** Rear right dining room chandelier and the third floor stairwell
- Action** Hire an electrician to make required repairs.
- Cost** \$120 - \$180

- 28 The switch is an improperly-wired three way switch. This affects proper function, and can be a shock hazard and safety concern. Location: Rear right dining room chandelier and the third floor stairwell. *Hire an electrician to make required repairs.* Estimated cost: \$120 - \$180

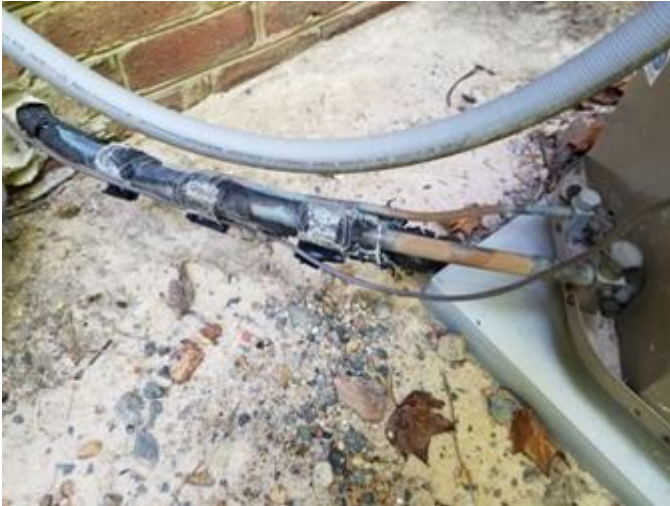
HVAC - Cooling System 1

- ✕ Issue The insulation at the refrigerant lines is damage/deteriorated.
- Location At all right side compressors
- Action *Hire an electrician to make required repairs.*
- Cost \$100 - \$150

- 29 The insulation at the refrigerant lines is damage/deteriorated. Location: At all right side compressors. *Hire an electrician to make required repairs.* Estimated cost: \$100 - \$150

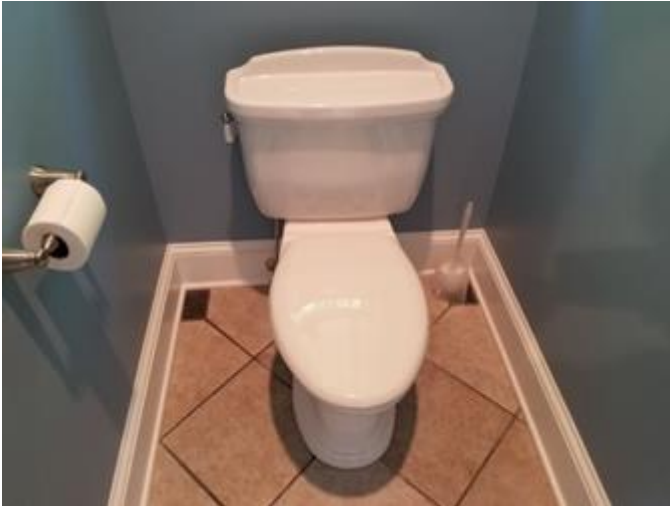
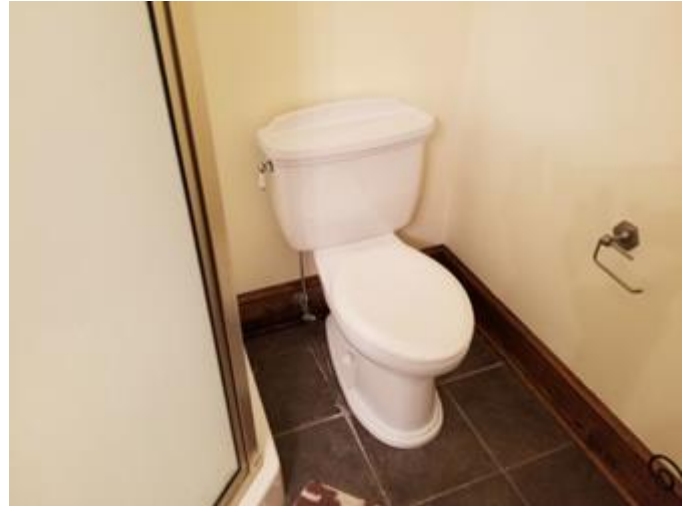
Plumbing - Toilet

- X** Issue The toilet base is loose at the floor. This permits leaks and causes water damage to surrounding areas.
- Location Master and basement bathrooms
- Action *Hire a plumber to make required repairs.*
- Cost \$180 - \$270

- 30 The toilet base is loose at the floor. This permits leaks and causes water damage to surrounding areas. Location: Master and basement bathrooms. *Hire a plumber to make required repairs.* Estimated cost: \$180 - \$270

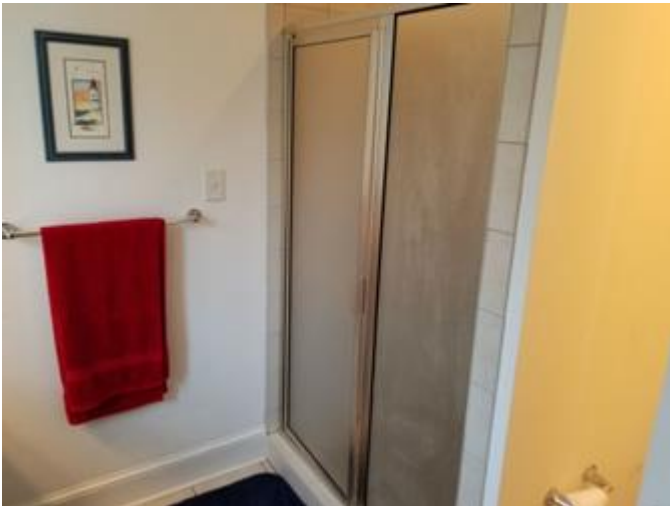
- X** Issue The tub/shower door needs adjustment or is broken. This affects proper operation, and can be a safety hazard.
- Location 2nd floor, rear left bathroom
- Action *Hire a plumber to make required repairs.*
- Cost \$100 - \$150

- 31 The tub/shower door needs adjustment or is broken. This affects proper operation, and can be a safety hazard. Location: 2nd floor, rear left bathroom. *Hire a plumber to make required repairs.* Estimated cost: \$100 - \$150

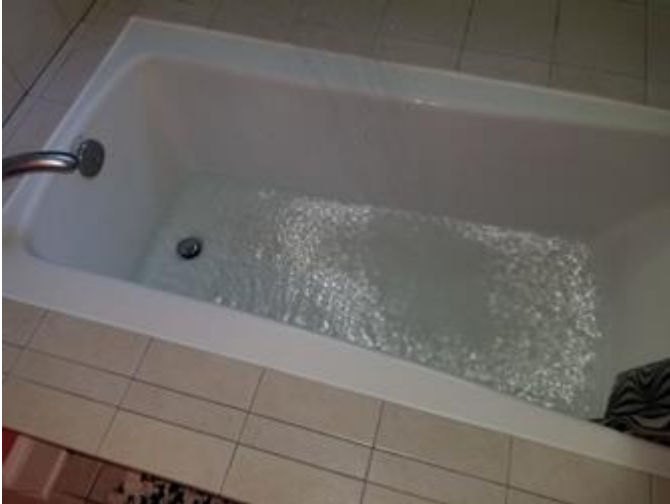
- X** Issue The tub/shower is slow to drain. This prevents proper function. As part of a visible general home inspection, the exact condition of the interior of the plumbing pipes could not be determined.
- Location 2nd floor, rear right bathroom
- Action *Hire a plumber to make required repairs.*
- Cost \$140 - \$210

- 32 The tub/shower is slow to drain. This prevents proper function. As part of a visible general home inspection, the exact condition of the interior of the plumbing pipes could not be determined. Location: 2nd floor, rear right bathroom. *Hire a plumber to make required repairs.* Estimated cost: \$140 - \$210

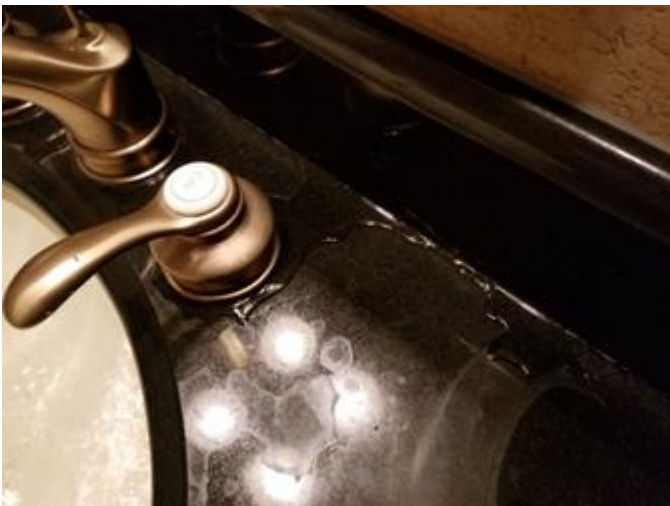
- X** Issue The sink faucet handle is leaking. This affects proper function.
- Location 1st floor, left side half bathroom- cold side
- Action *Hire a plumber to make required repairs.*
- Cost \$100 - \$150

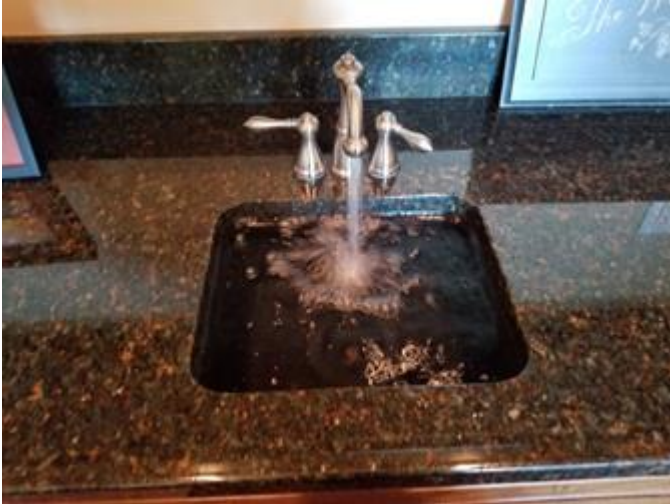
- ❌ **Issue** The sink is slow to drain. This prevents proper function. As part of a visible general home inspection, the exact condition of the interior of the plumbing pipes could not be determined.
- Location** 1st floor, rear left bar sink, second floor rear left bathroom,
- Action** *Hire a plumber to make required repairs.*
- Cost** \$180 - \$270

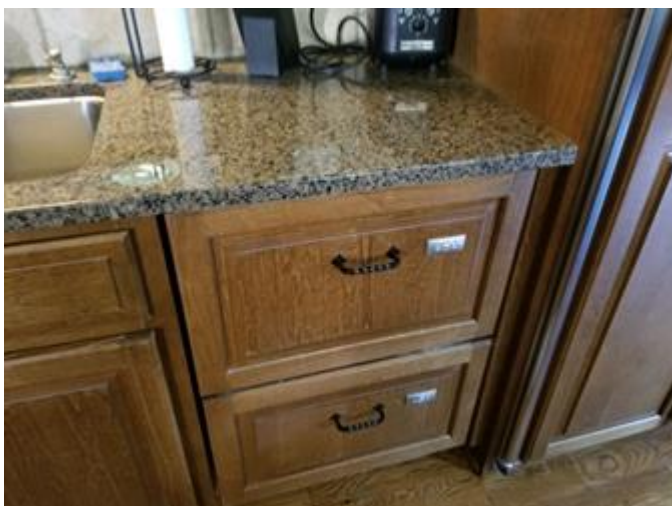
Appliances - Dishwasher

✗ **Issue** The dishwasher leaks. This affects proper operation and can cause damage.
Location Kitchen, top dishwasher
Action *Repair or replace the dishwasher.*
Cost \$220 - \$330

- 35 The dishwasher leaks. This affects proper operation and can cause damage. Location: Kitchen, top dishwasher. *Repair or replace the dishwasher.* Estimated cost: \$220 - \$330

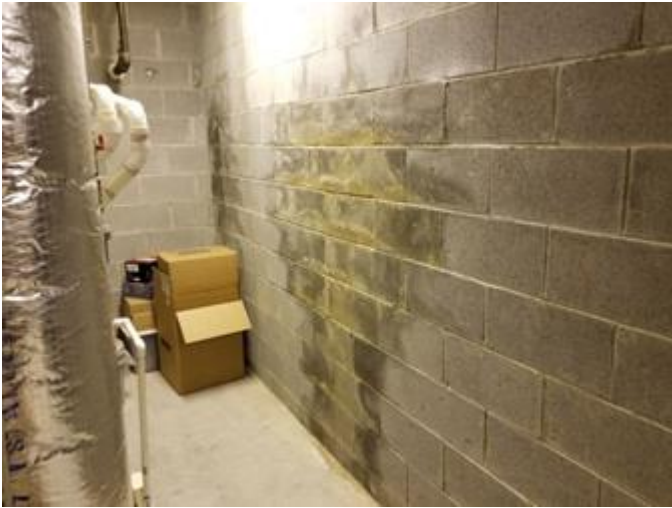
- Water appears to be coming through the foundation wall.

- 36 There are conditions which are conducive to water penetration into the structure. Hire a contractor for further evaluation and repairs. Location: Unfinished section of the basement, right side.

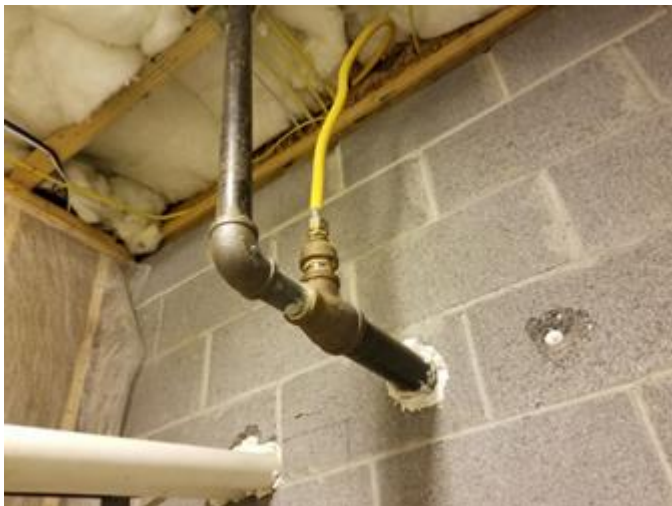
UNBONDED GAS LINES

There are unbonded CSST gas lines present. This is a safety hazard. Hire an electrician for further evaluation and repairs.

- Front left section of the unfinished basement
